**Federal Building and Fire Safety Investigation of the
World Trade Center Disaster**

**Mechanical and Metallurgical
Analysis of Structural Steel**

September 2005

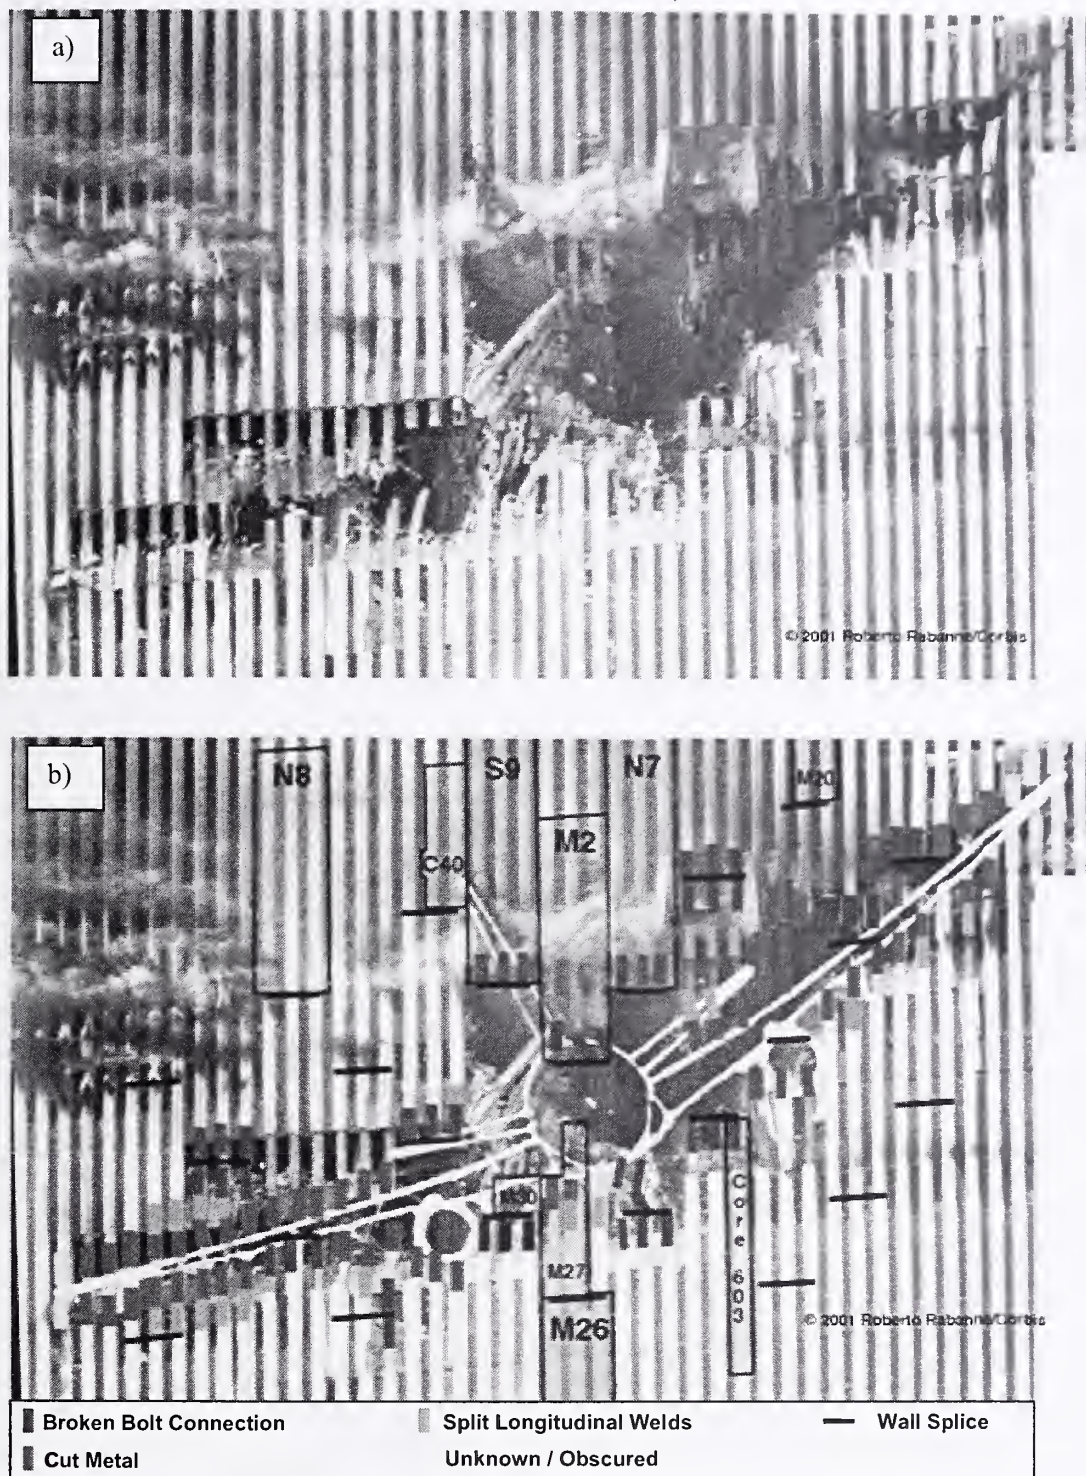
Figure 6–1. (top) Enhanced image showing the impact hole in the north face of WTC 1, and (bottom) overlay of an outline of a Boeing 767 that has been distorted to get a best approximate fit with damage to WTC 1. The location and type of localized damage has been indicated.

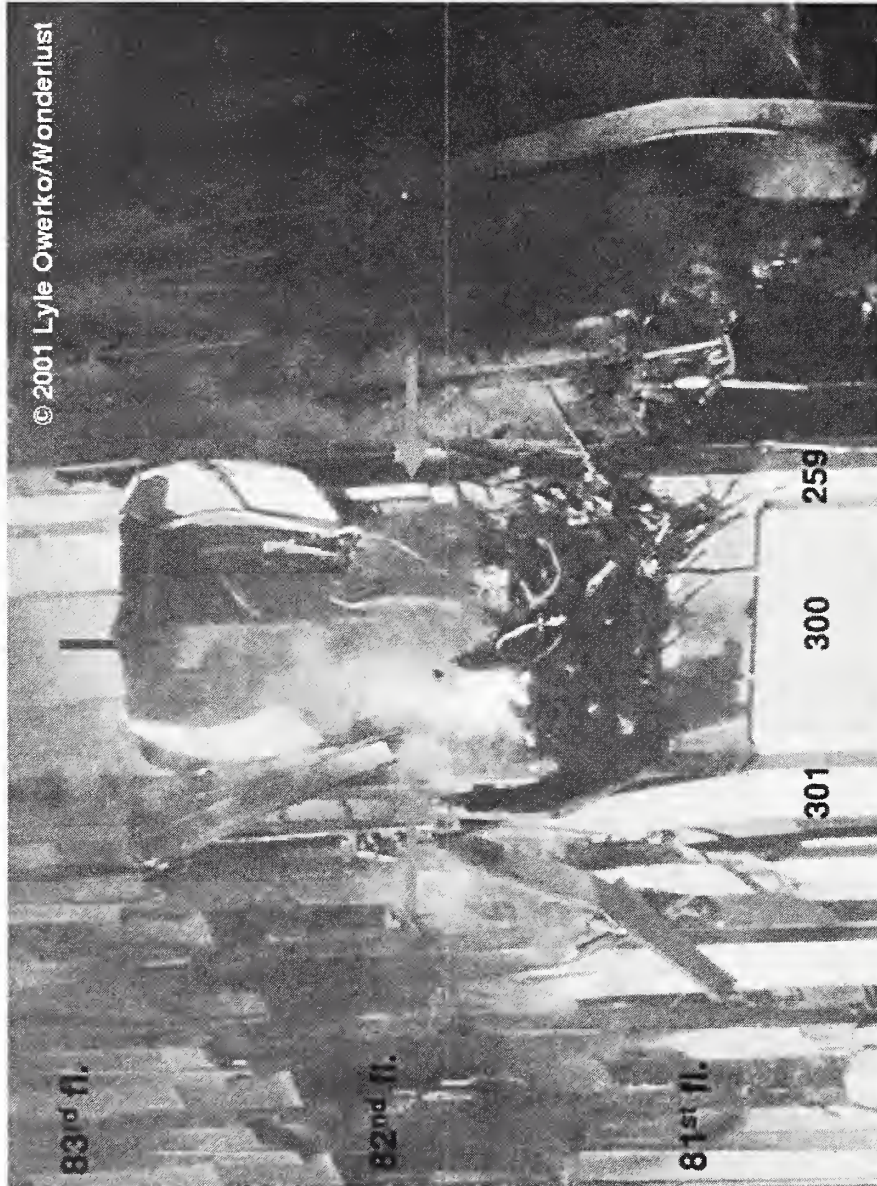
Figure 6-3. Damage to northeast corner of WTC 2 at 81st floor. The red arrow indicates an intact column 300 at the 82nd floor. Other photographs confirm that the spandrel connecting column 300 to columns 259 and 301 is also intact (location indicated by green arrows).

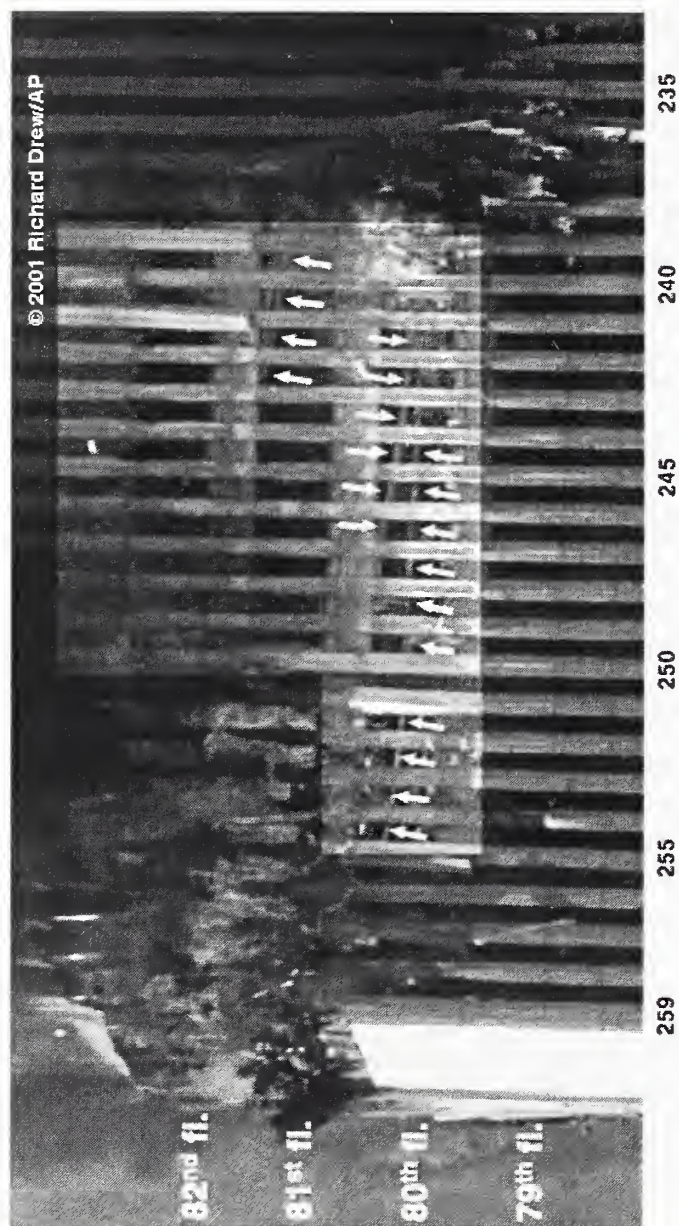
Figure 6-5. Dropped floors on north face of WTC 2.

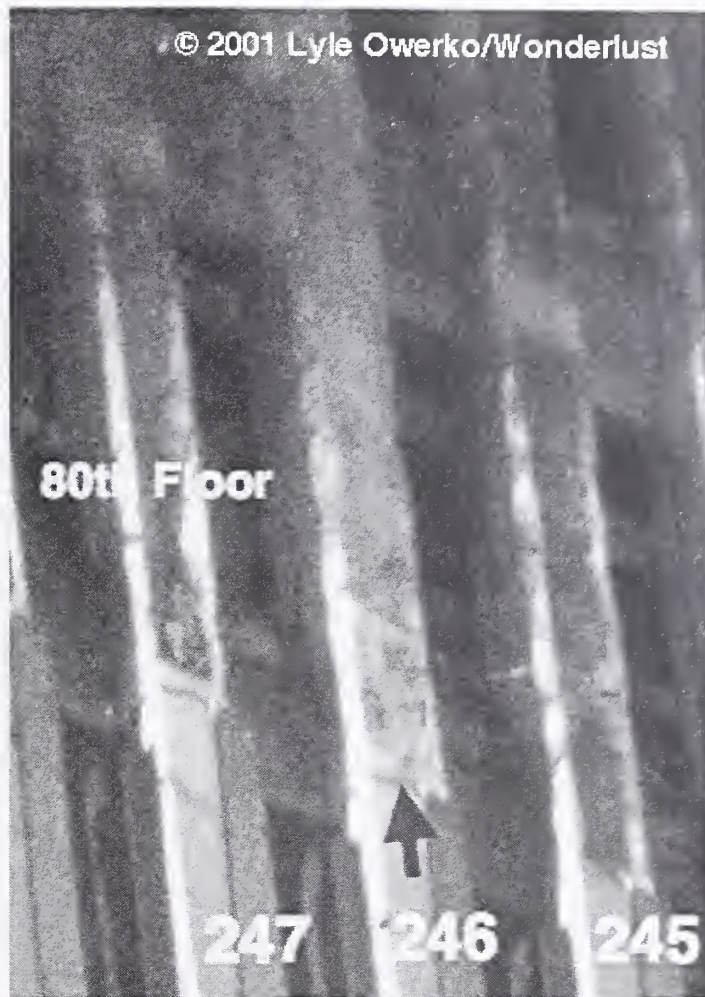
Figure 6–7. Fireproofing that had been applied to the exterior columns. The depression formed by the outer web and the flange tips are completely filled in with fireproofing at the arrow. North face of WTC 2.

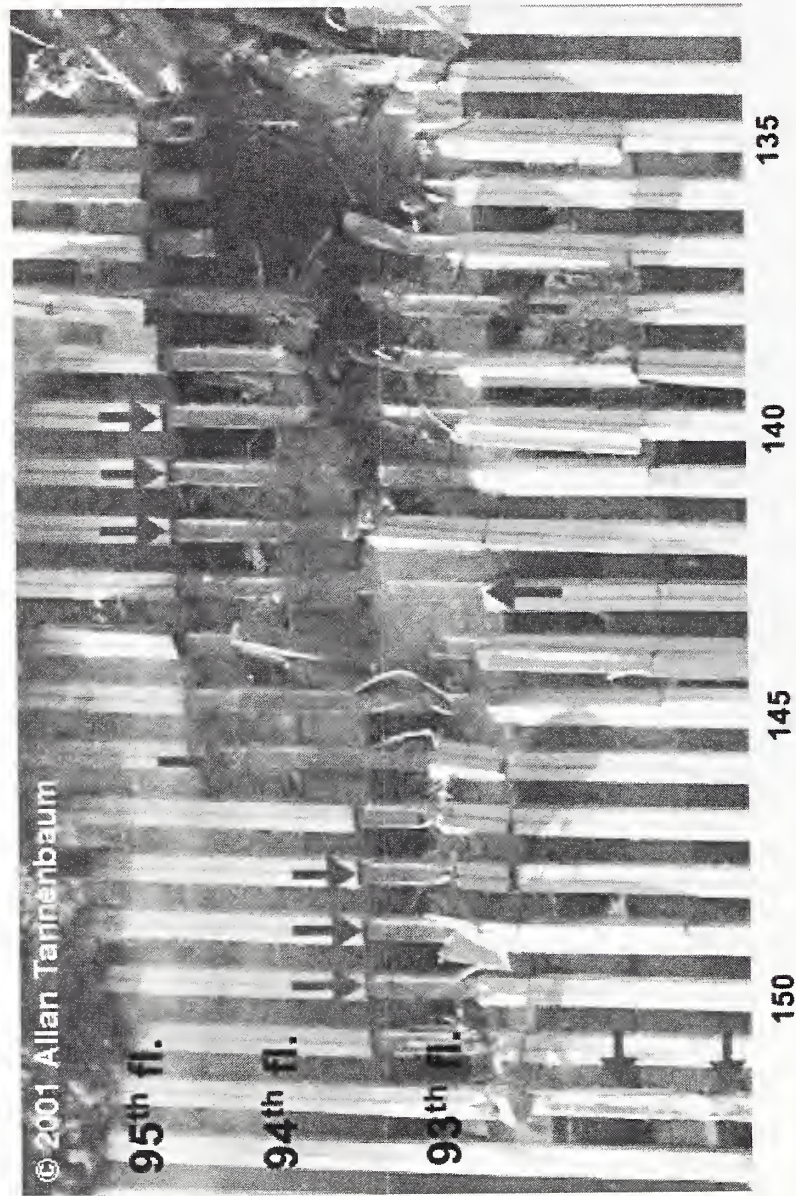
Figure 6-8. Port side of impact hole in north face of WTC 1 showing missing fireproofing. The red arrows indicate a few of the many instances of missing fireproofing around the impact hole. The region roughly approximated as the area where the aluminum panels were dislodge has been digitally enhanced for clarity.

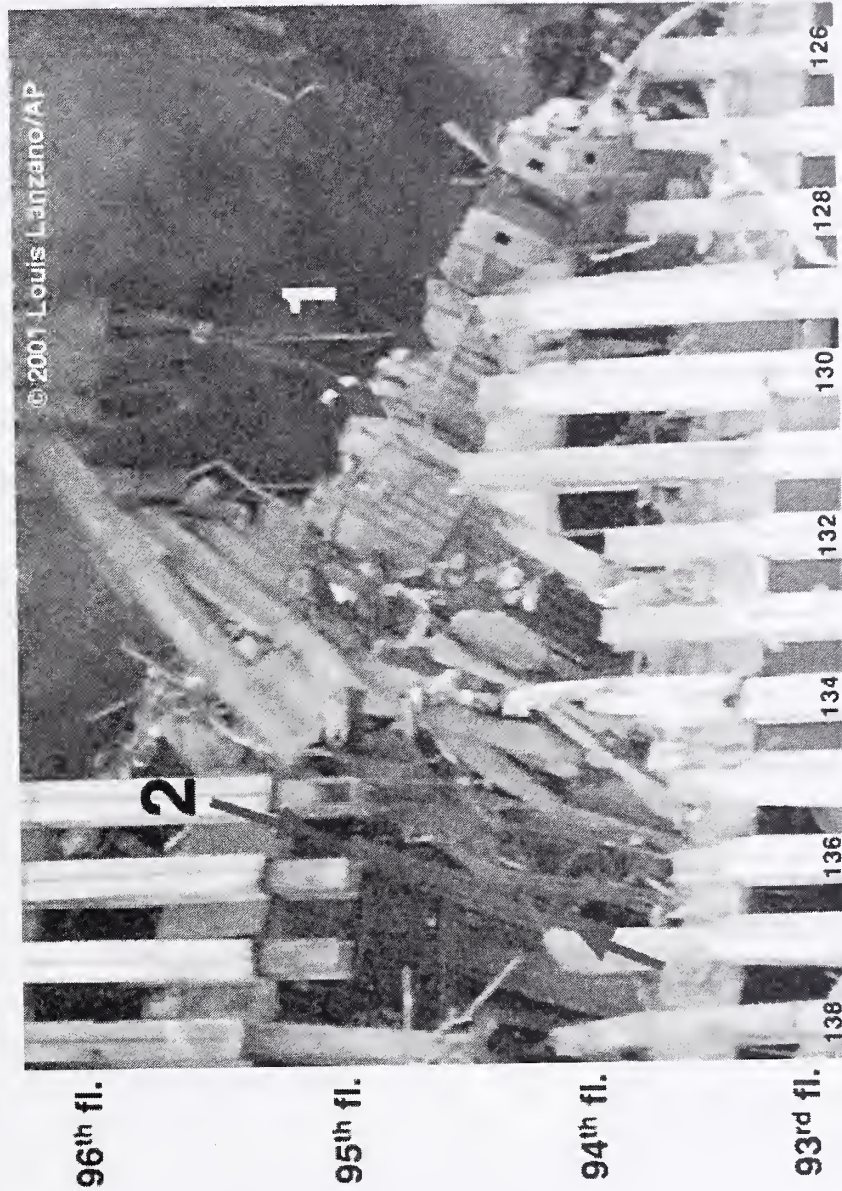
Figure 6–9. Missing fireproofing on floor trusses that fell into impact hole on north face of WTC 1. The arrows labeled “1” are three trusses where the lower or upper chords can be seen, and can distinguish the line that separates the two angle iron components. The arrows labeled “2” lie at either end of a lower chord of a truss that fell farther inside the building, and is made up of four angle irons (a double truss). The red paint color being visible and the fact that the line between the angle iron can be seen indicated that the fireproofing was displaced.

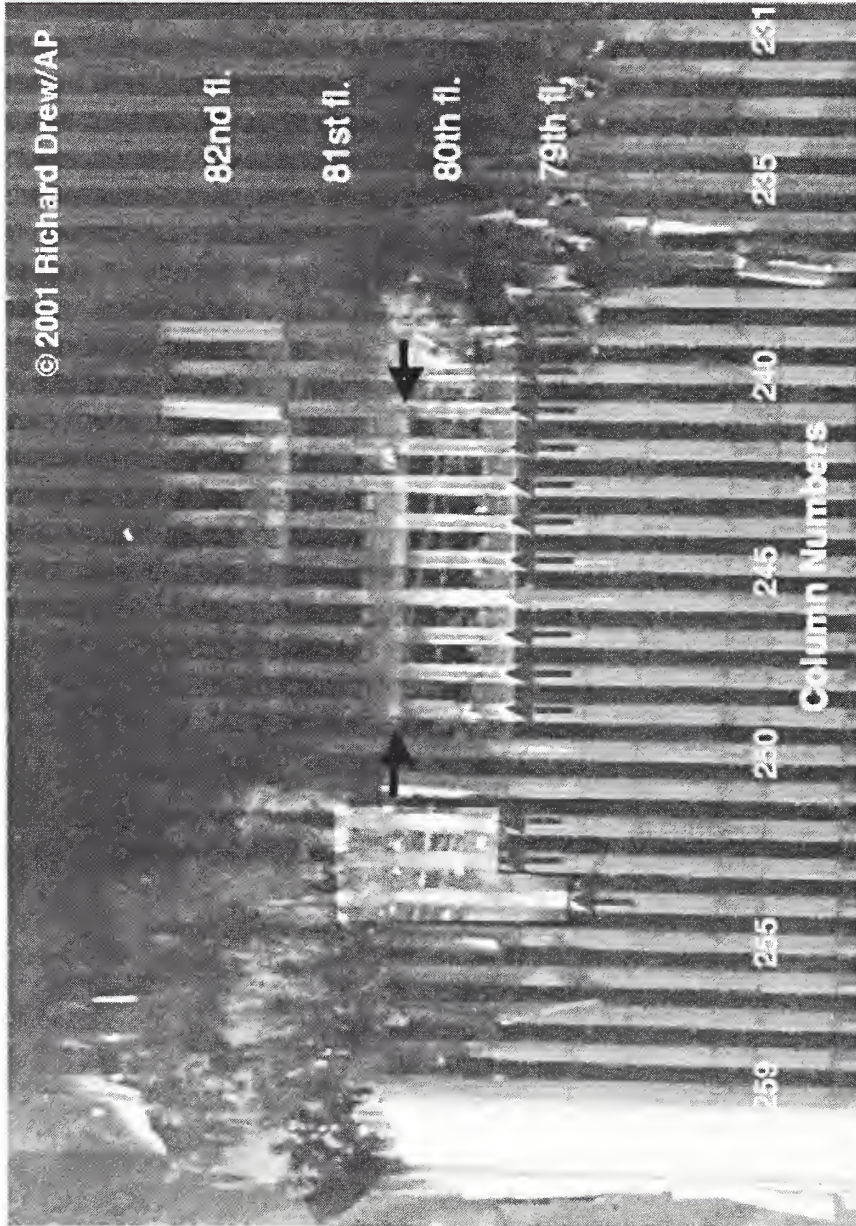
Figure 6–10. Missing façade and fireproofing on north face of WTC 2. Two regions have had contrast and gamma adjusted to enhance visibility of the features. Red arrows indicate columns with missing or damaged fireproofing. Missing or damaged fireproofing determinations were made from this and several other photos taken at different times and angles. Blue arrows indicate white features where some sort of coating has preserved the fireproofing in place.

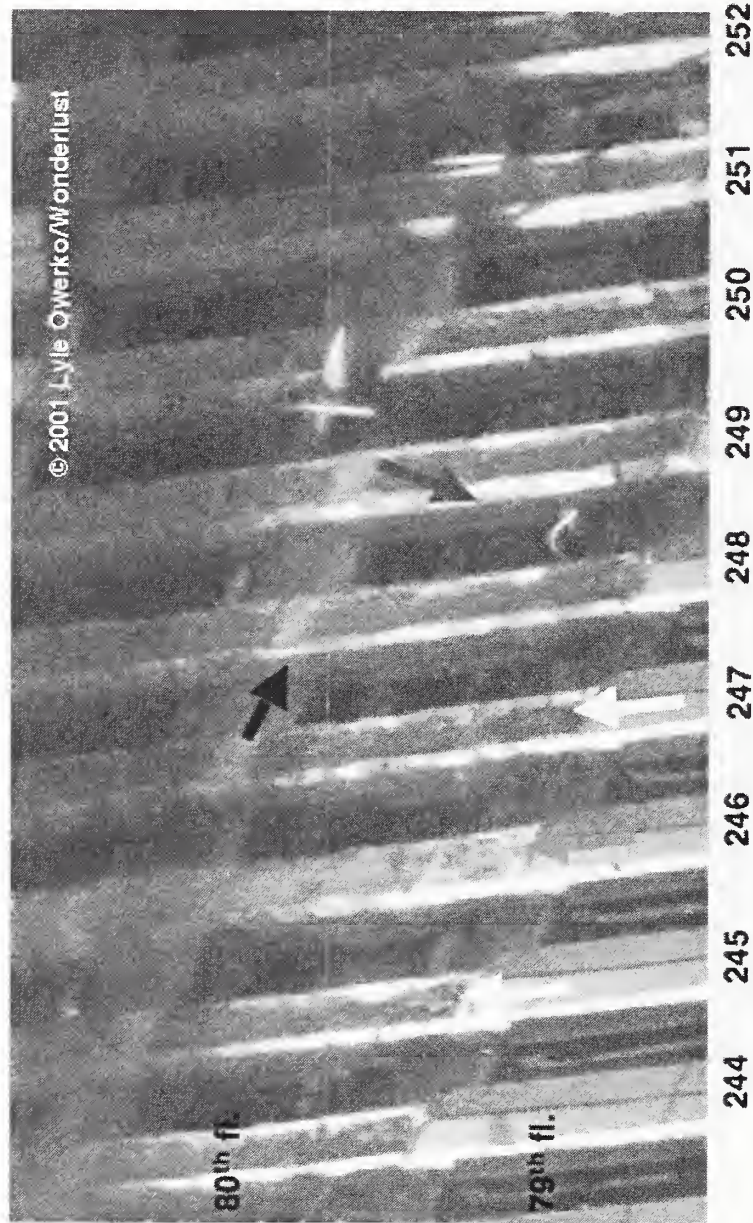
Figure 6-11. Missing fireproofing on flanges of exterior columns of north face of WTC 2. Fireproofing has come off, revealing red Tnemec paint of the column (red arrows). This image also shows how the outer web regions have been partially or completely denuded of fireproofing. Damage is evidenced by shading by sunlight - compare green (undamaged fireproofing) and white (damaged fireproofing) arrows. Blue arrow indicates same type of white coated area of fireproofing as previous figure that adhered when material above and below was dislodged.

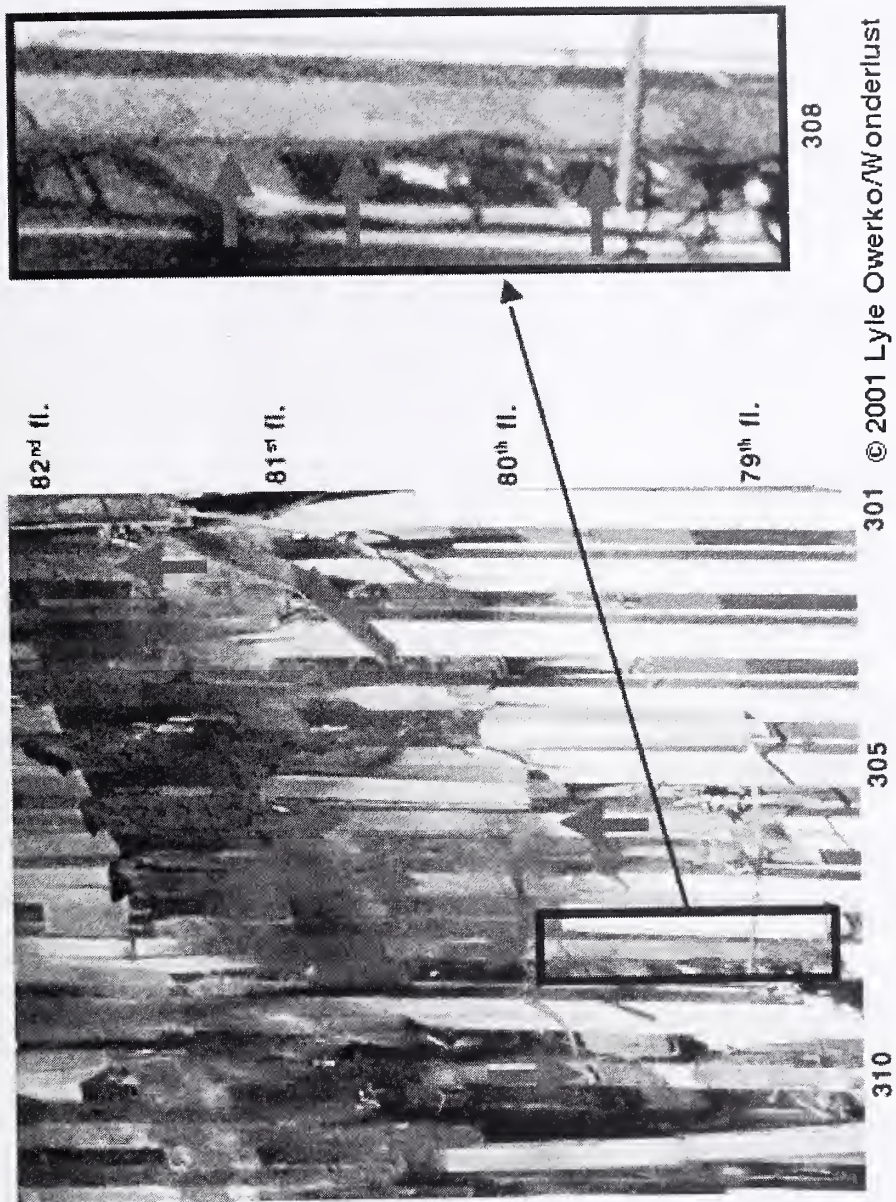
Figure 6-12. Damage to fireproofing on east face of WTC 2 due to internal impact. Red arrows highlight areas where fireproofing has been damaged. The blowup to the right shows a column where the red Tnemec paint of the column is visible.

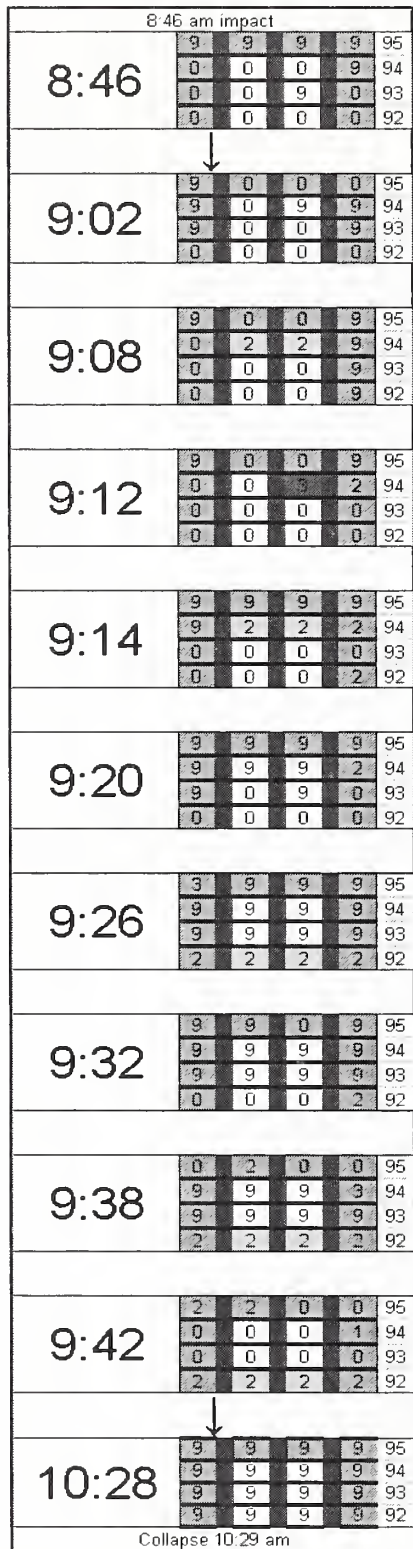
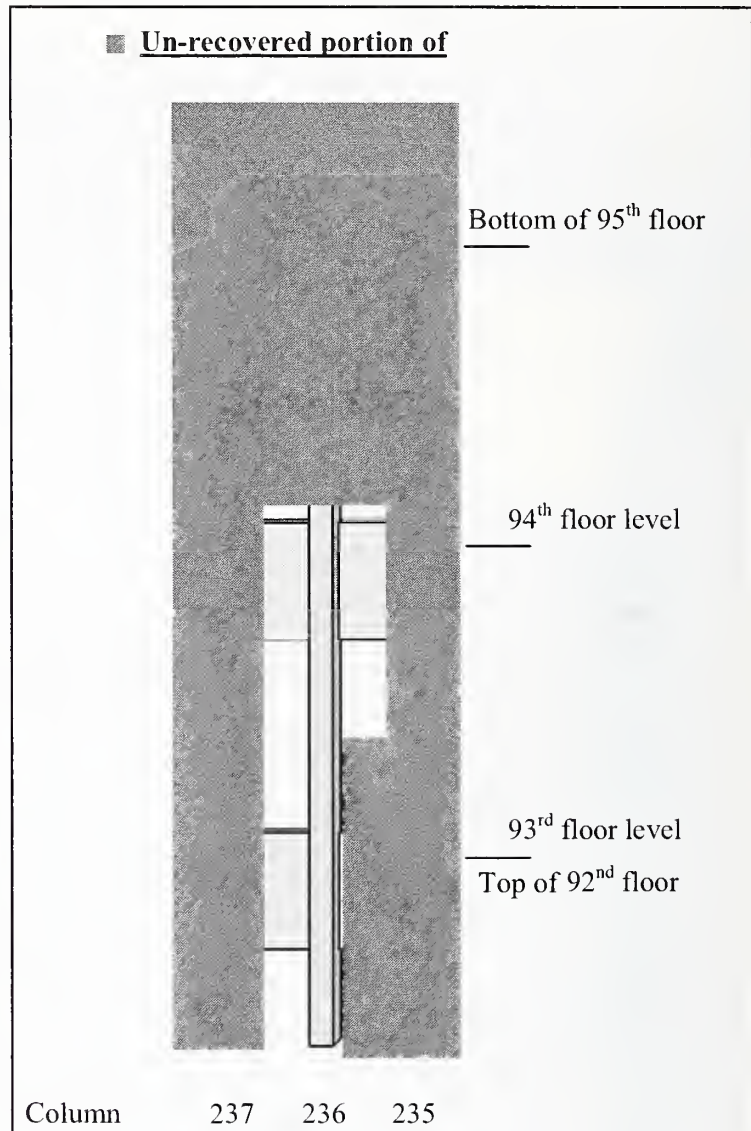
NIST Name: K-2
Panel ID: A236: 92-95
Panel location: WTC 1, East face

External flaming	3
Fire inside	2
Spot fire	1
No fire evident	0
No determination	9
Unrecovered portion of panel	#

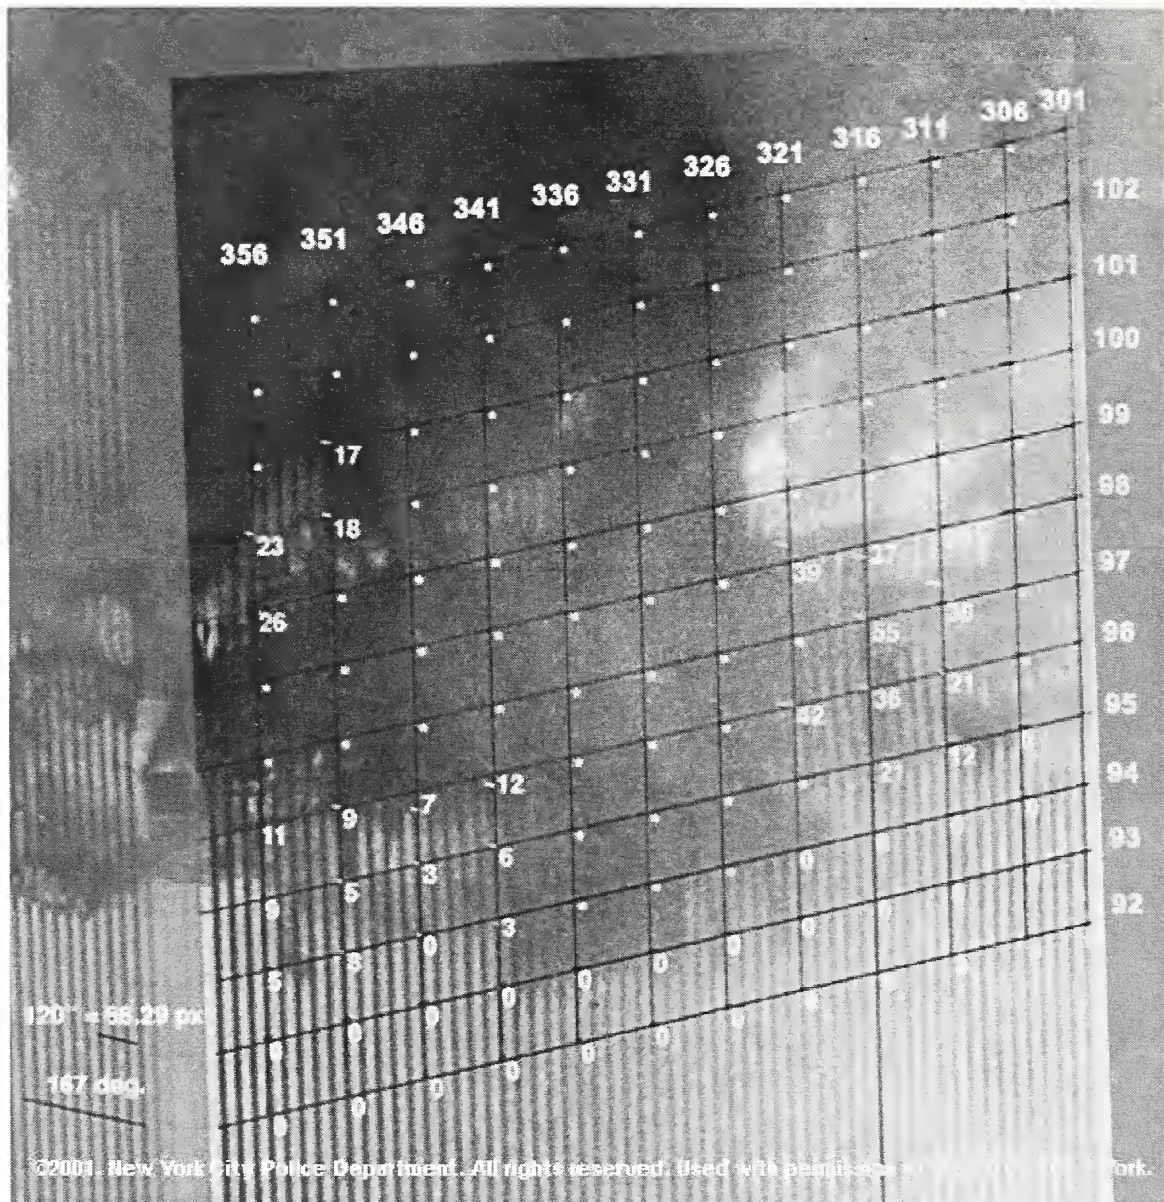
Figure 6–15. Pull in of south face of WTC 1 at 10:23 a.m. showing considerable displacements of outer columns into the building. Faint white vertical features are the aluminum façade of the exterior. Maximum visible inward displacement of the columns is 55 in. +/- 6 in. Poor resolution leads to large uncertainties in measurements; a large fraction of the south face of the building is obscured by smoke.

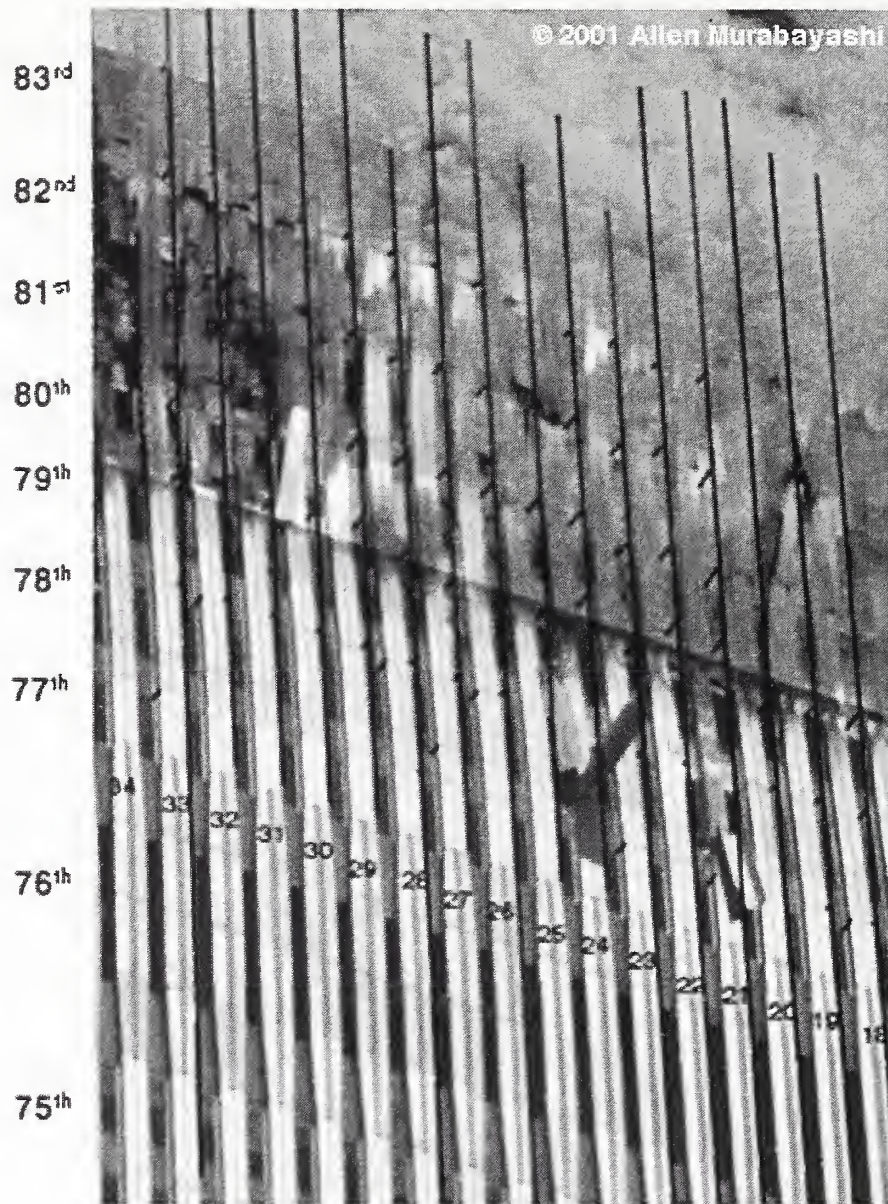
Figure 6–16. East face of WTC 2 at 9:53:04 a.m. showing a larger amount of pull in. The vertical black lines were drawn to establish the original line of the exterior wall columns, and the shorter line segments are drawn at the same angle as the nearest observable joint in the exterior aluminum panels to establish the inward bowing distance. For actual column numbers, add a “3” to the front of the two-digit designations in the image.

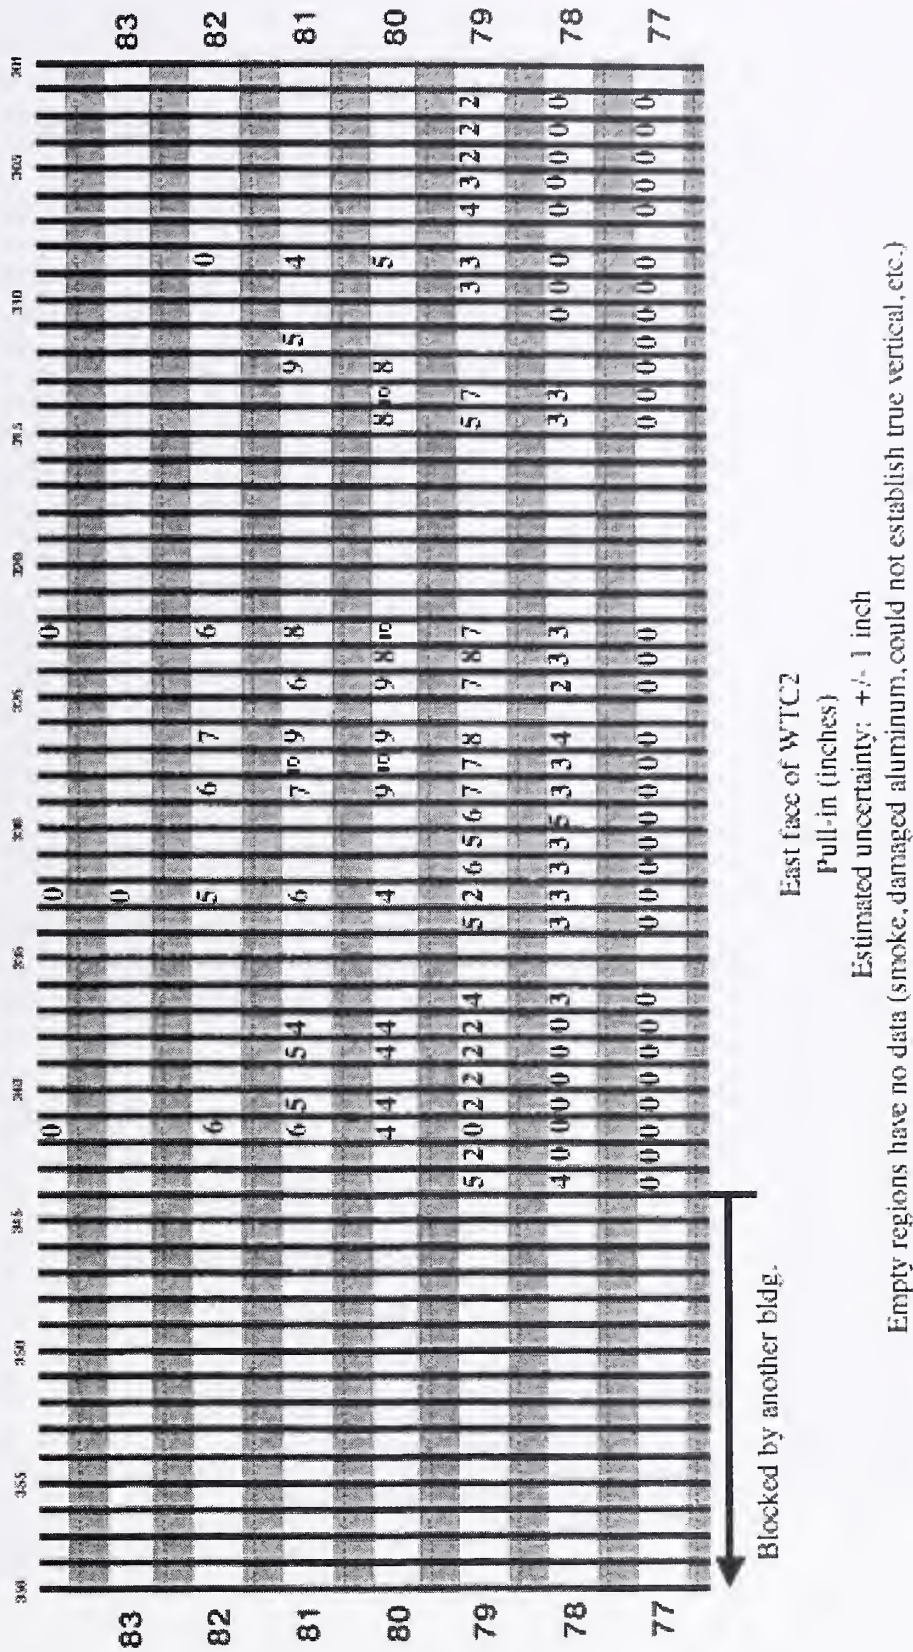
Time: 9:21:29 AM

Figure 6-17. Map of inward displacements of the east outer face of WTC 2 inward at 9:21:29 a.m. Each measurement refers to the upper left corner of the window within which the number resides. Measurements were in inches. The colors refer to groups of 5 in. displacements (0-5: black, 6-10: blue) for easier visualization.

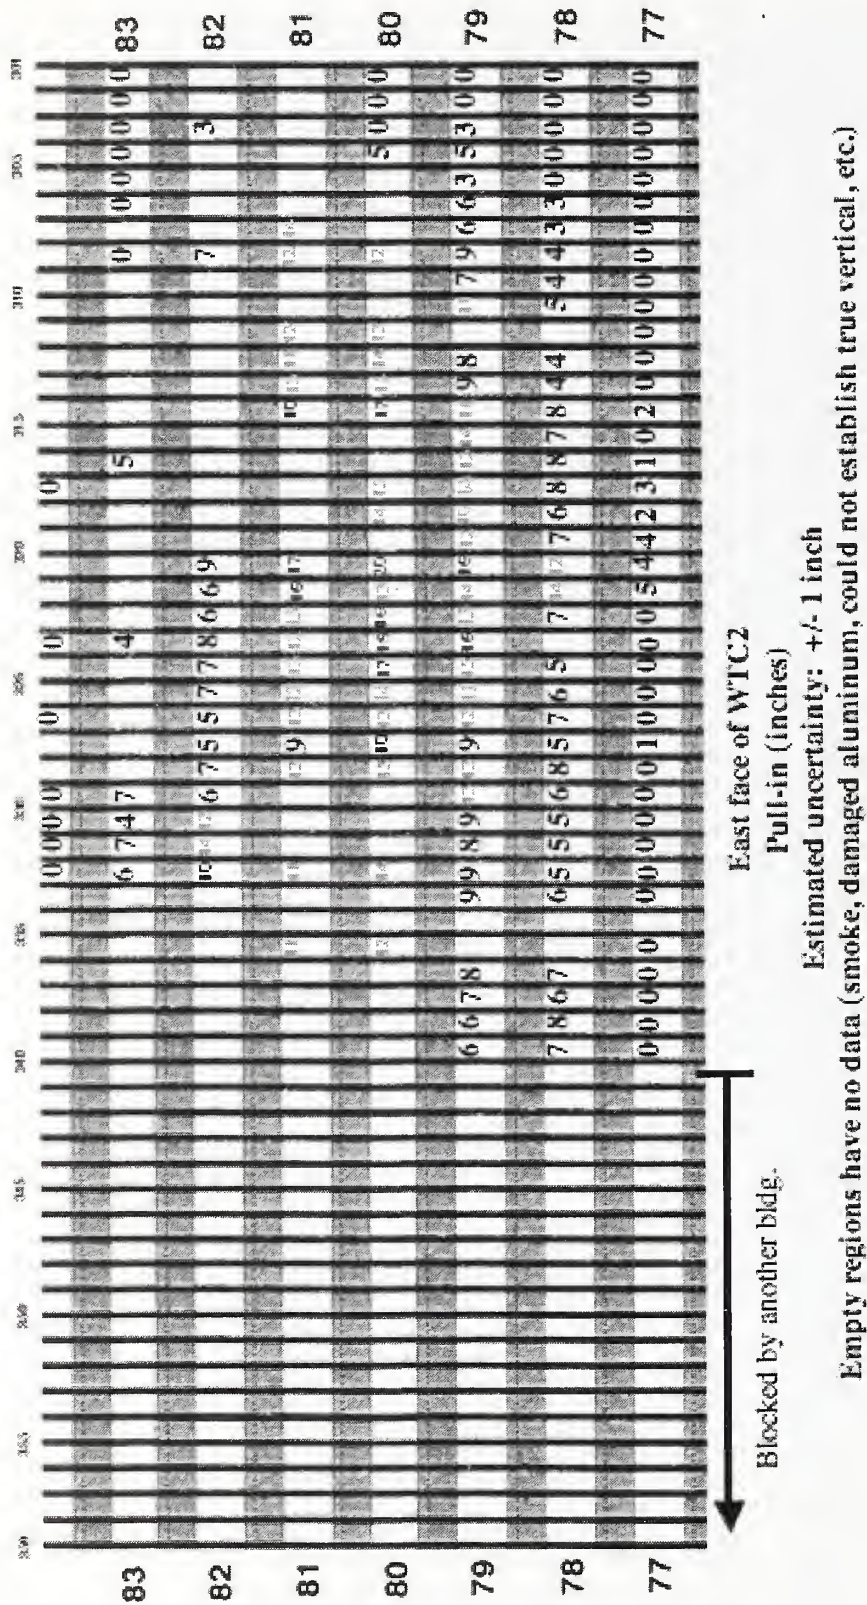
Figure 6-18. Map of pull in displacements of the east outer face of WTC 2 inward shortly before collapse. Each measurement refers to the upper left corner of the window within which the number resides. Measurements were in inches. The colors refer to groups of 5 in. displacements (0-5: black, 6-10: blue, 11-15: orange, 16-20: red) for easier visualization. This data was combined from two images taken by the same photographer at nearly the same location 10 s apart, and it is assumed that the inward deflection did not change appreciably during this time.

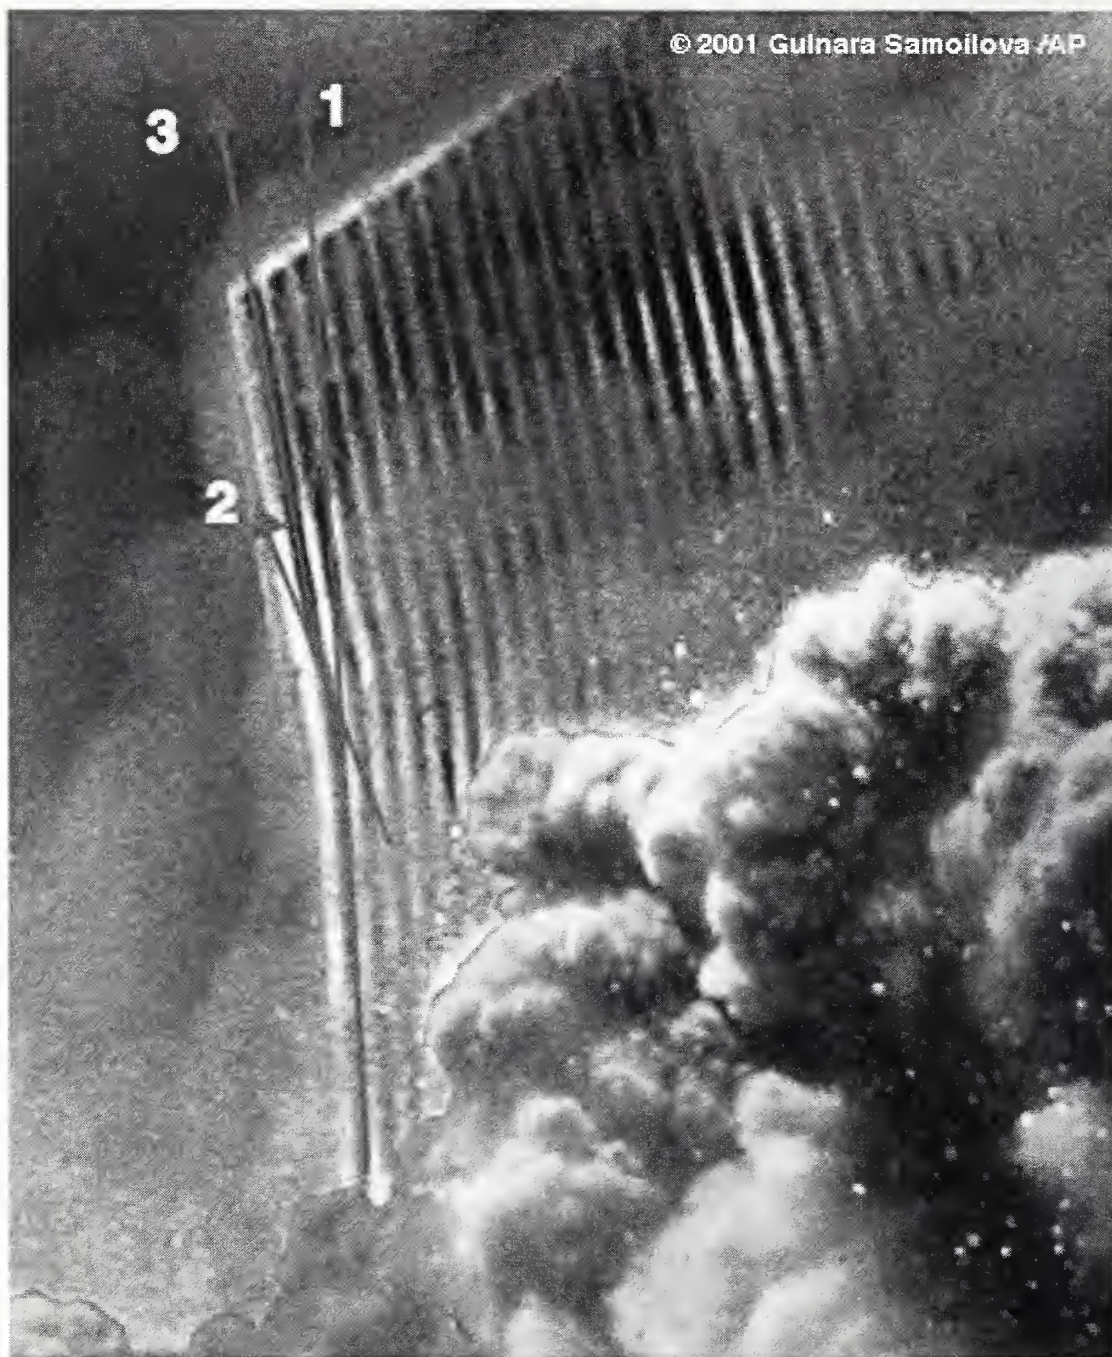
Figure 6–20. A close-up of the kink area in the previous figure (southeast corner, WTC 2), with overlaid lines to highlight the details of the kink geometry. The edge of the building (1) bends an angle to another direction (2), then bends back somewhat toward the original direction (3).

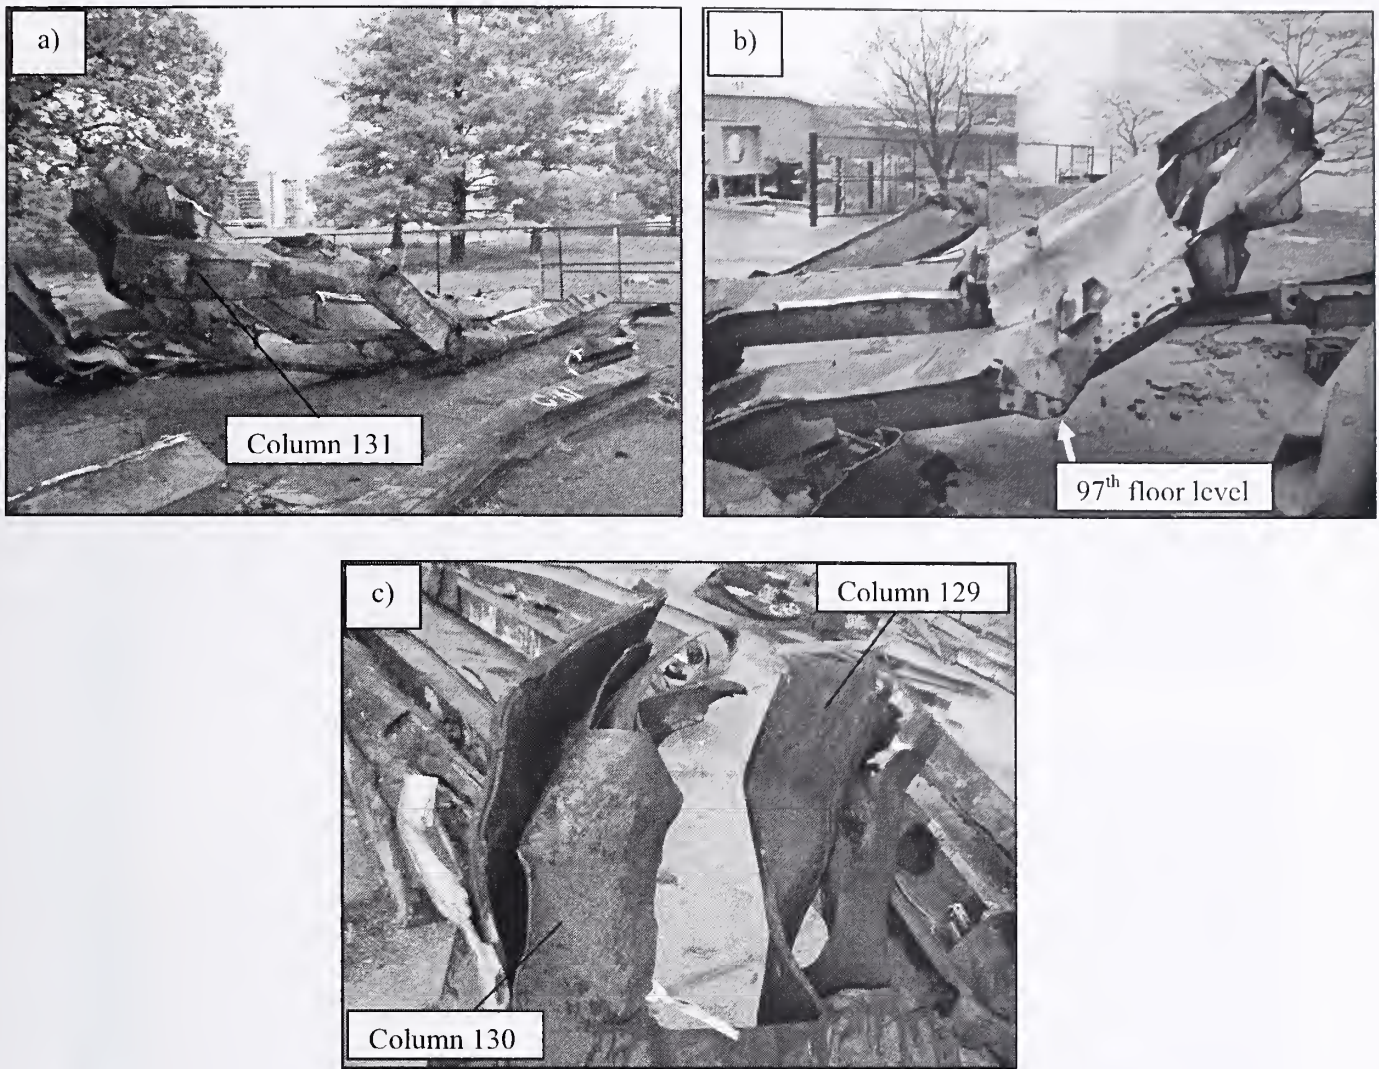
Panel M-2 (WTC 1, column line 130, floors 96 to 99) was struck by the upper part of the airplane's fuselage and the vertical stabilizer of its tail. In the photographic images (Fig. 6-1 [top]), the condition of the panel appeared remarkably similar to its as-recovered condition, Fig. 6-22a. The damage observed on the recovered panel was largely a result of the impact. The lower part of all three columns was bent into the building with the 97th floor concrete slab acting as a fulcrum point, Fig. 6-22b. Also, the lower end plates of columns 129 and 130 were ripped off with column plate fracture occurring near welds with to the butt plates, Fig 6-22c. This gave the columns a "splayed" appearance. The end plate for column 131 was still intact, and the lower portion of the column was relatively undeformed. In the pre-collapse images, the lower portion of this column is also bent inward just below the 97th floor spandrel; however, it was bent back out sometime during or after the collapse.

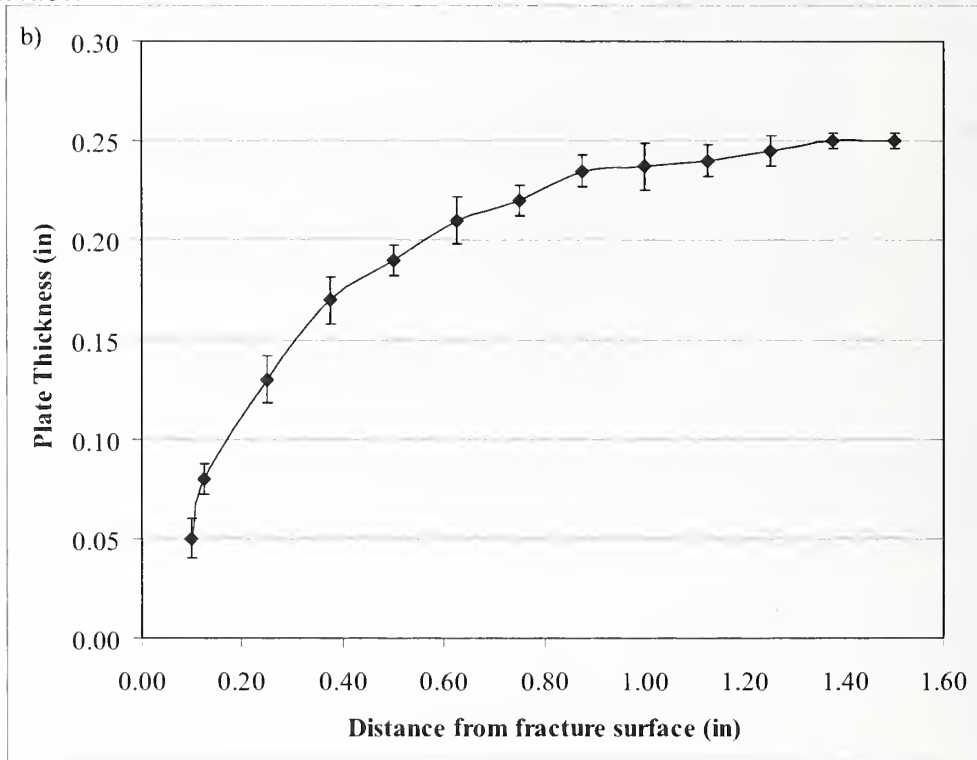
Figure 6–23. Thinning of outer web from column 130 of panel M-2 (A130: 96-99).
a) Photograph showing thinning, b) graph indicating plate thinning near fracture surface.
